The Requirement of Fluoroscopy During Pacemaker Battery Replacement

Key Words: Pacemaker replacement; fluoroscopy; complication; DDDR devices

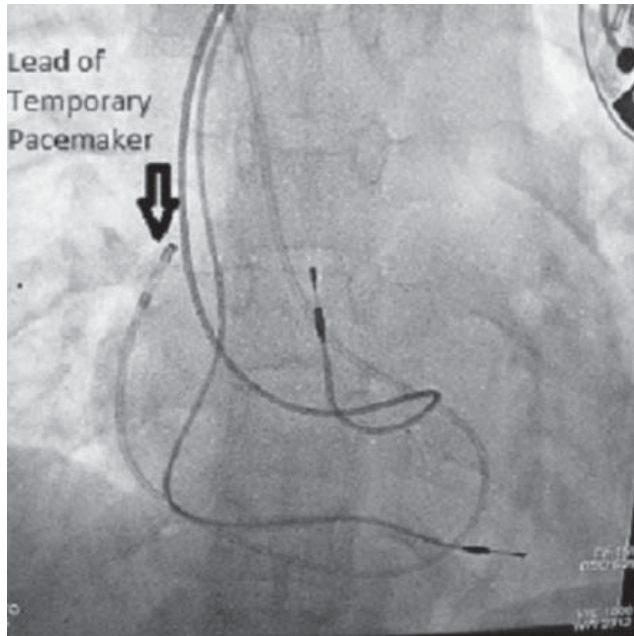
Figure 1. Anteroposterior fluoroscopic view of temporary and permanent pacemaker leads.

removed, it resulted in cardiac arrest. Subsequently, fluoroscopy was performed with anteroposterior (AP) projection and an image was obtained, as shown in Figure 1. As seen in Figure 1, she had a really large right atrium and the lead of the temporary PM was found in the right atrium instead of the right ventricle, and it had been pacing the right atrium during the threshold testing before the operation. Then the activity of the atrium was sensed by the atrial lead of the permanent PM that worked on the atrial-sensed ventricular-paced (As/Vp) mode. Thus, there was a wide QRS and left bundle-branch block (LBBB) pattern and at the rate of equal to temporary PM's rate rhythm had been occurred. In other words, the rhythm with wide QRS complex and LBBB pattern did not occur by a direct stimulation of the temporary PM but as a result of the As/Vp function of the permanent PM.

After the fluoroscopy, the lead of the temporary PM was placed in the right ventricle and the replacement of the battery was performed successfully.

In the absence of adequate intrinsic cardiac activity, if battery replacement has to be performed on DDDR-mode devices, the temporary PM lead must be implanted under fluoroscopic control and it must be ensured that it is appropriately placed in the ventricle.
